Sample Report

Re: 0070 NE Wyoming St
Silverdale, WA 98383

Inspection Report
0070 NE Wyoming St
Silverdale, WA 98383
Prepared for: Sample Report

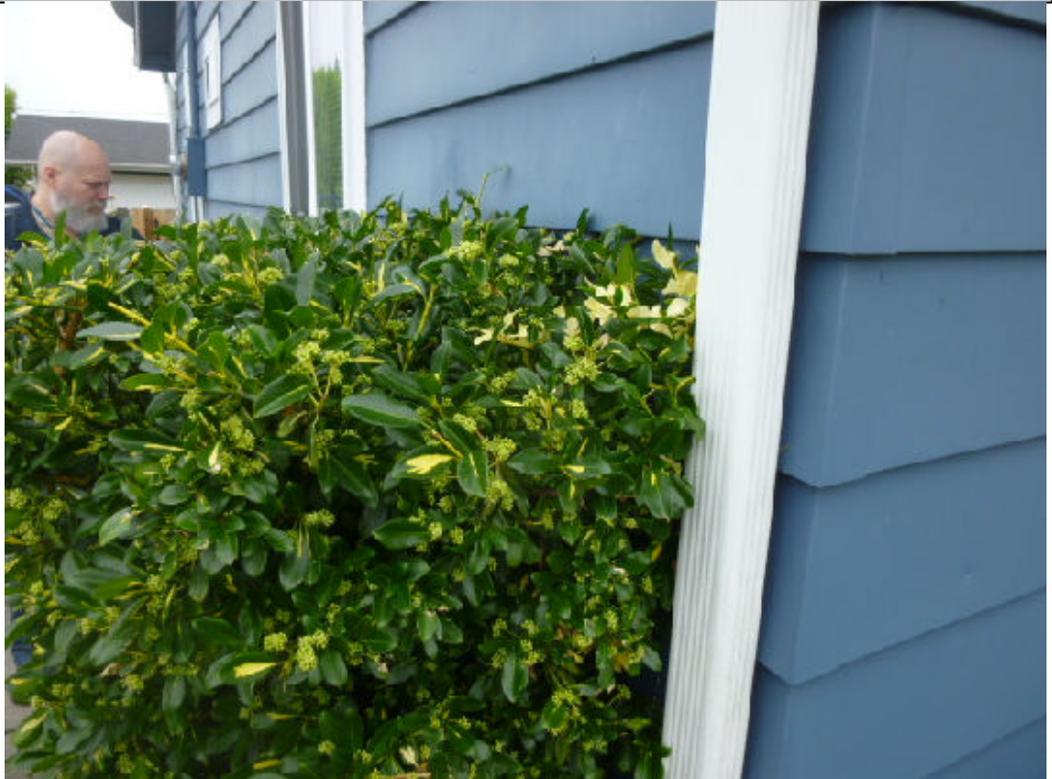
Grounds appear to be maintained. Vegetation was found to be contacting the exterior of the home. Recommend trimming vegetation away from structure to increase ventilation and sunlight and reduce moisture problems.

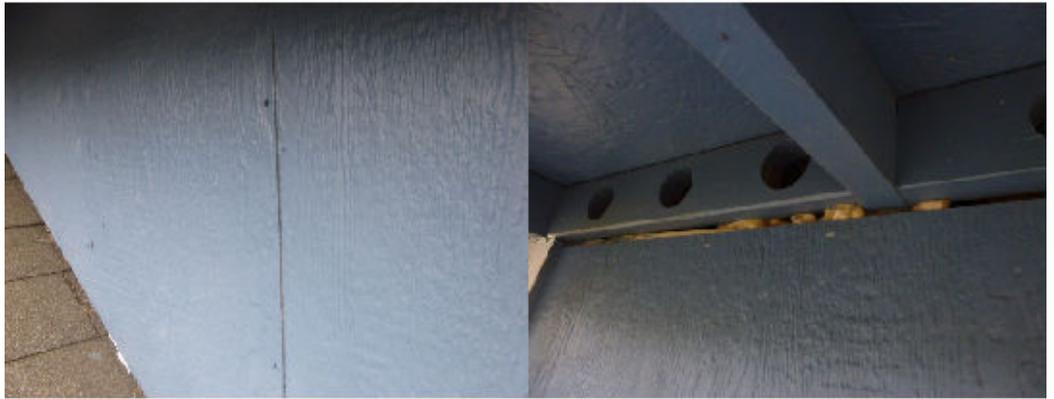
**Gaps at siding panels and under soffits**

LP siding at second story was functional, however, open gaps were noted between lap panels and where siding butts soffits/bird blocking. Recommend re-caulking siding butt joints, corner boards, and around any trim boards that are attached to the exterior walls. Caulking is not a permanent fix and will need to be re-applied every couple of years to seal the exterior walls. All open gaps need to be sealed. Nail heads were also found to penetrate the surface of the siding product. Typically, the head of the nail should not pierce the surface of the siding material. Where this occurs, primer paint and caulking should be applied to seal the raw wood and prevent moisture damage. Paint/stain is recommended. Deterioration from advanced weathering was present. Most houses need to be repainted about every 8-10 years. The most important part of the process is the preparation. The surface should be cleaned and sanded, then primed and painted.

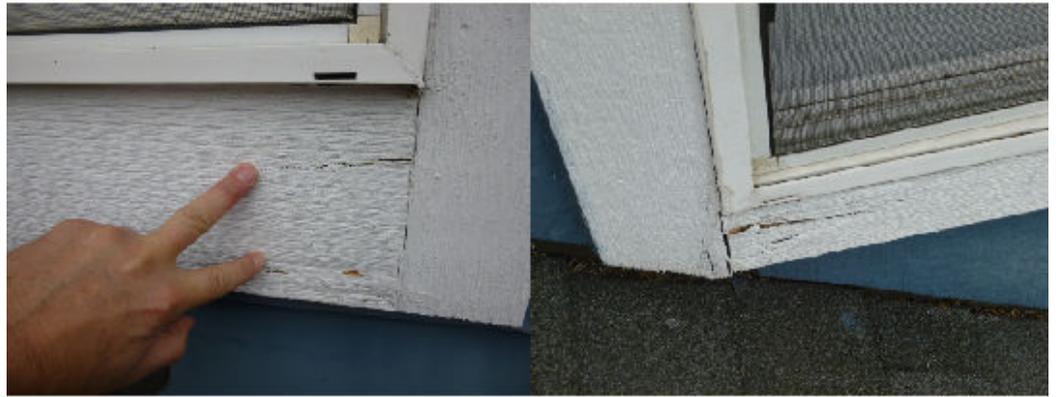
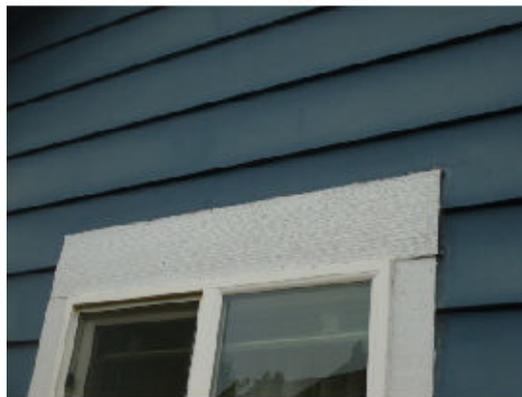
**Wood rot at window trim/No Z-style flash**

Trim rot was noted at several windows where window weep holes allow water to drain over lower trim board. Wood was soft when probed. Recommend replacing damaged trim. Also, no head flashing was installed above horizontal trimwork. It is strongly recommended that all exterior trim be properly flashed at upper edge to prevent water entry behind trimwork. Oftentimes, caulking is used in place of metal flashing, however, this is not recommended as caulking only provides a temporary seal. Hidden damage may occur within the wall structure as a result of improperly flashed trimwork. Caulking is deteriorated above exterior trim. Re-caulk any gaps that are present around window trim, corner boards, and any horizontally attached trim boards. This is a primary source of water leakage and can allow water to seep between the siding and trim leading to rot conditions. Fascia boards were found to be stained from moisture at the gable ends. Typically, water will run off the roof edge over the ends of the fascia boards resulting in moisture damage. Recommend replacing any damaged fascia boards and installing flashing at upper edge to prevent future rot damage. Consult with a licensed siding contractor as needed for repairs.

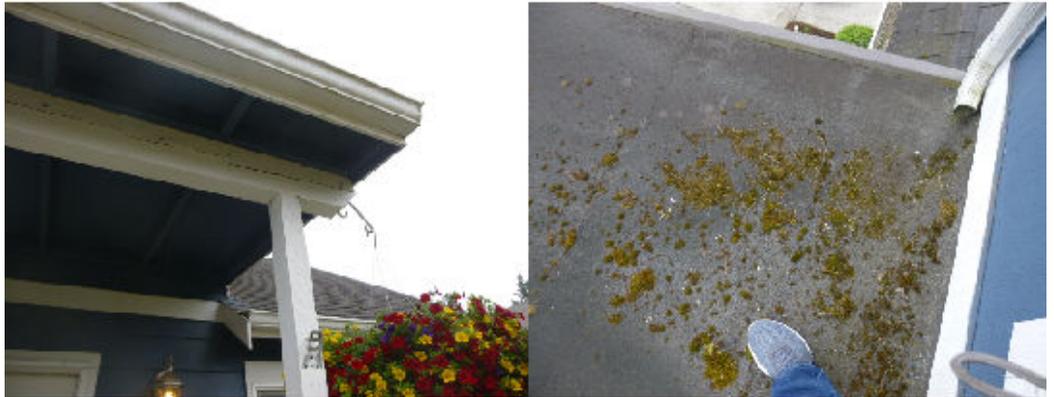
**No ties at post/beam- Weatehrd roofing**

Front porch posts were found buried in concrete porch. This is not recommended as the post bases will rot out over time. Consider adding metal spacer brackets to secure base of posts to concrete and prevent wood/concrete contact. Also, wood posts and beams need to be fastened with metal strapping to secure the connections. The rolled comp roofing material is deteriorated/damaged from weathering and downspouts draining onto lower roof. Repairs are recommended to prevent any leakage. Recommend further evaluation and repairs by a licensed contractor.

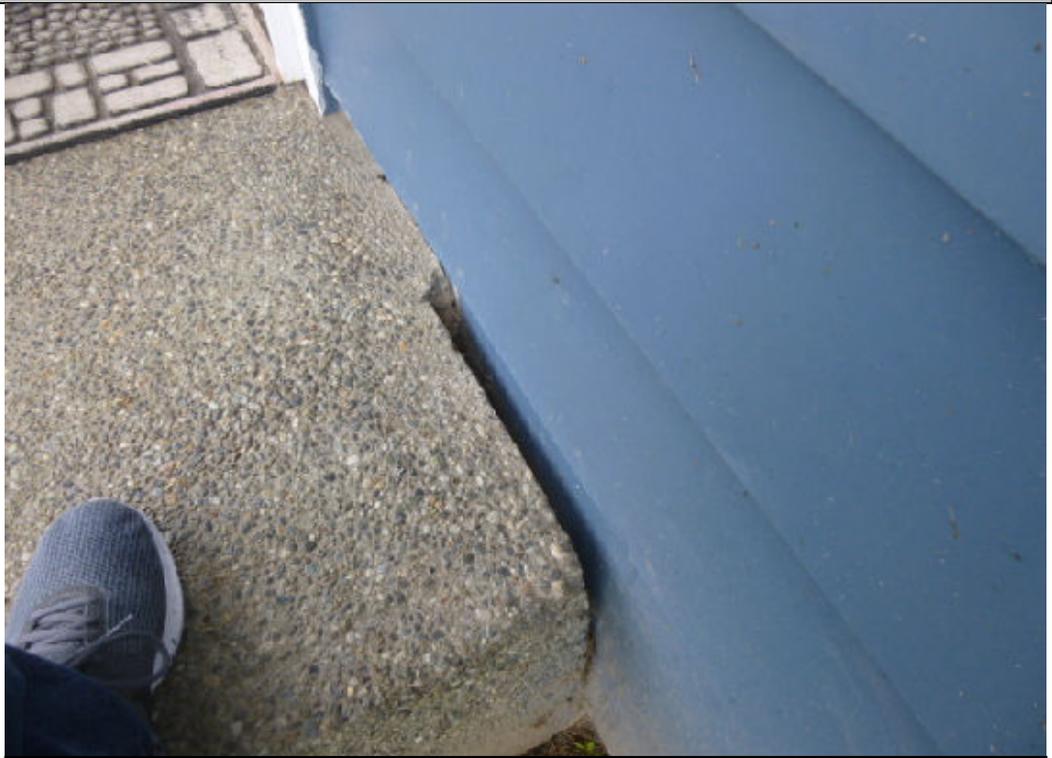
**Siding/concrete contact**

Stoop/stairs appear to be in serviceable condition and within proper rise/run tolerances. It appears that the concrete porch/steps was poured over an existing step. Concrete steps at the front/rear porch were in direct contact with the siding/structure. Typically, a vapor barrier is installed between the two types of materials to prevent rot conditions. Unable to determine if a moisture barrier was installed properly. It is nearly impossible to inspect this area without damaging the siding or the concrete steps. Rot conditions may exist. It is recommended that this area be sealed at the surface where water may seep between the concrete and the siding. If obvious rot conditions are present, the removal of the damaged wood is advised.

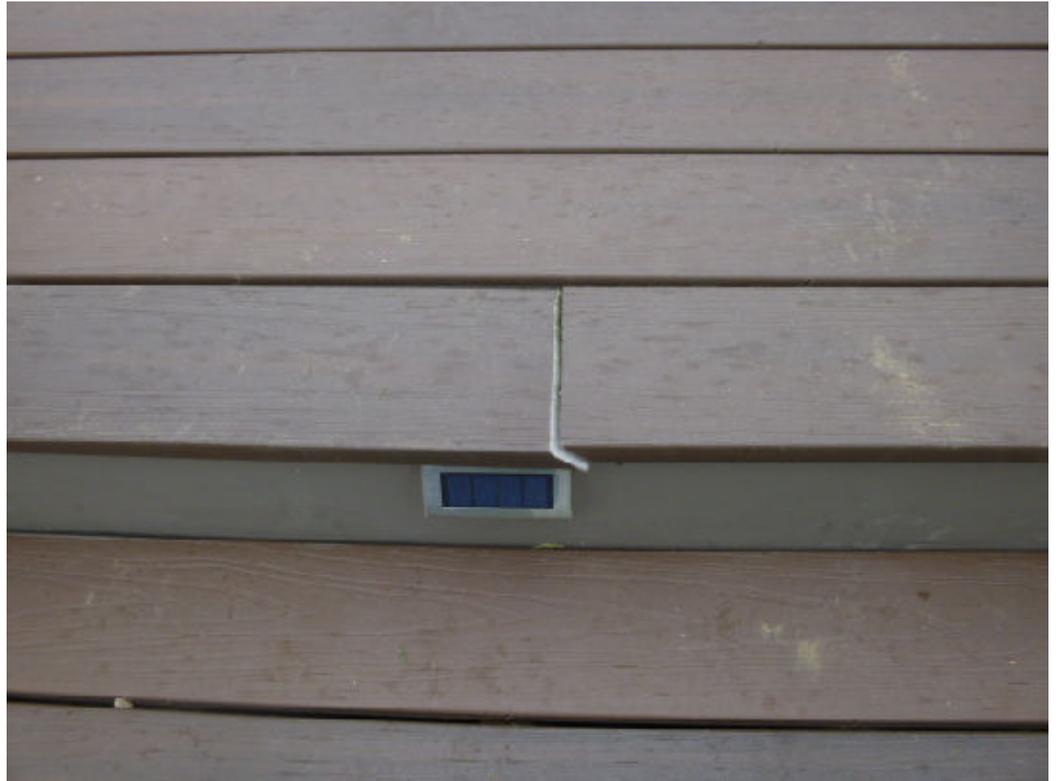
The decking boards appeared functional and without rot conditions. Lag bolts were present securing the deck's header joist to the exterior wall. Flashing was found to be installed above the header joist where the deck is attached to the home. Deck board at rear step has shifted and needs repairs. Consider replacing board as needed.

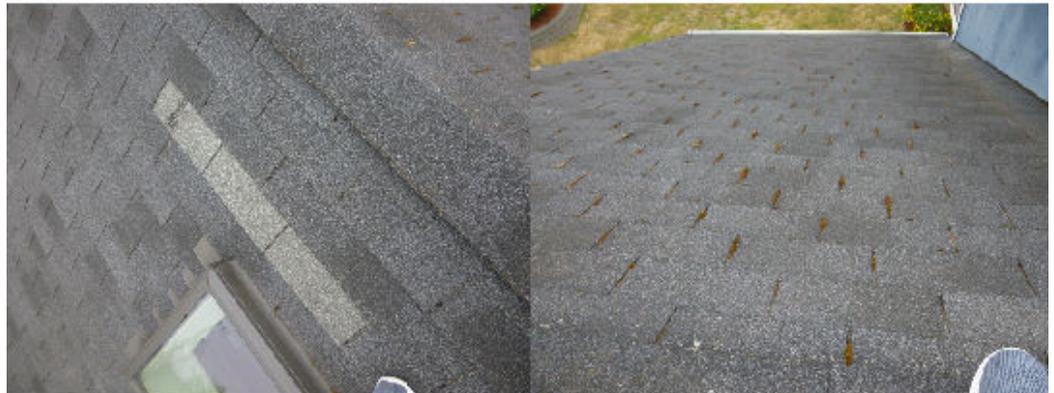
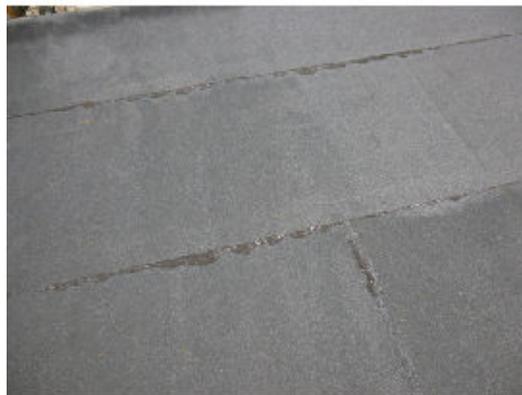
Replaced shingle/Moss/Dormer flat roof

The roofing material appears functional and within useful life. Evidence of roof repair above skylight. Repair appears functional- no indication of leakage was visible. Consult with seller regarding history of roof repairs. Moss was observed growing on the surface. Moss can damage the roof and will reduce its effective life. Remove chemically, with caution. See your local building supply store for detailed product availability and use. After removing current moss consider installing zinc flashing and/or "Tide Detergent" at the peaks of the affected sides of the roof to prevent further

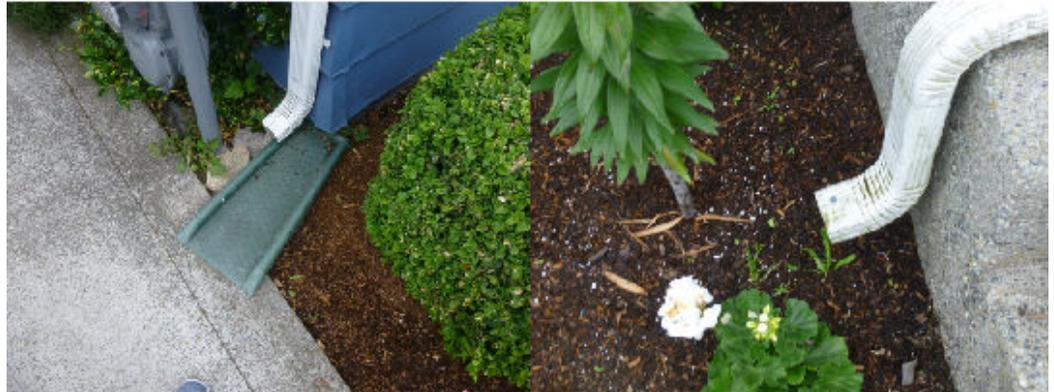
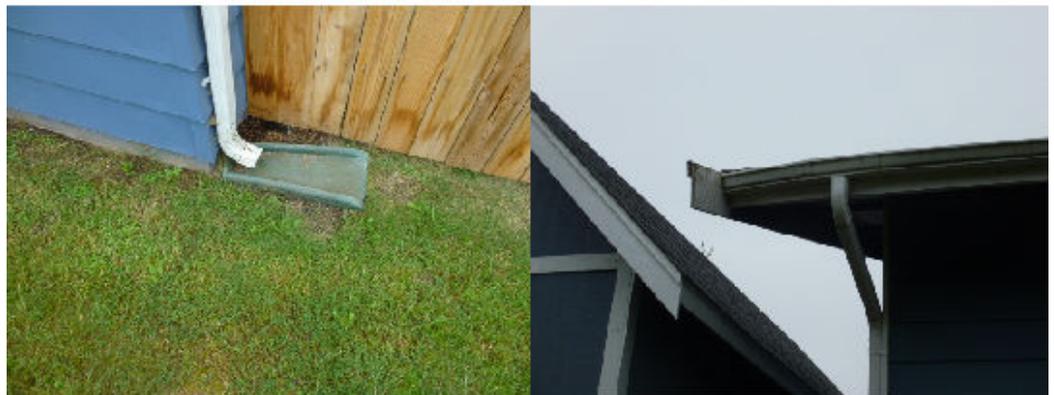
Metal gutters and downspouts. All downspouts are discharging near the foundation. The water should be diverted away from the foundation with splashblocks or leaders to prevent excessive moisture conditions around the foundation. A significant amount of storm water is diverted from the surface of the roof. A properly directed drain system will prevent excessive moisture conditions around the foundation. Also, at the garage, the rear South side gutter is sloped incorrectly at the SW corner. Repairs are needed to divert storm water towards downspouts. Gutter runs at garage were found with rust. No leakage or holes were visible at gutters.

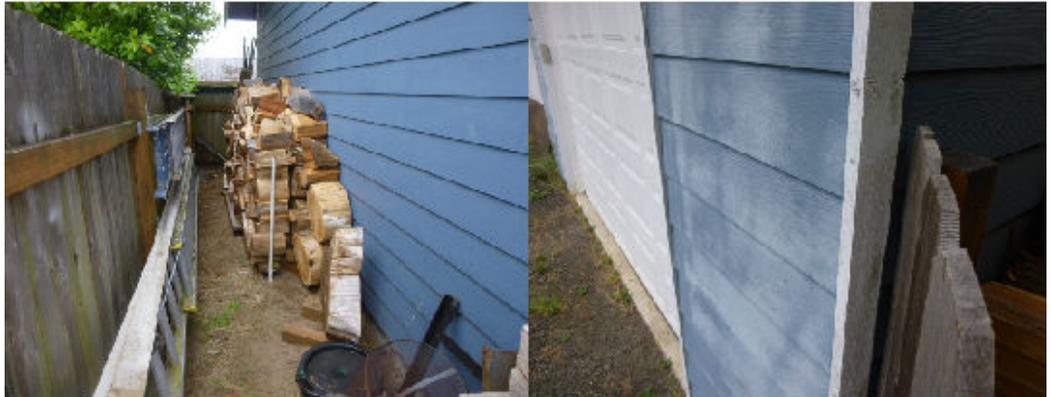
Wood against exterior wall/Faded paint

Hardi Plank lap siding. Paint and caulking recommended at wood trim and siding. Paint was faded significantly at South and West exposures. Also, it is not recommended that firewood be stored against exterior walls to prevent possible WDO infestation.

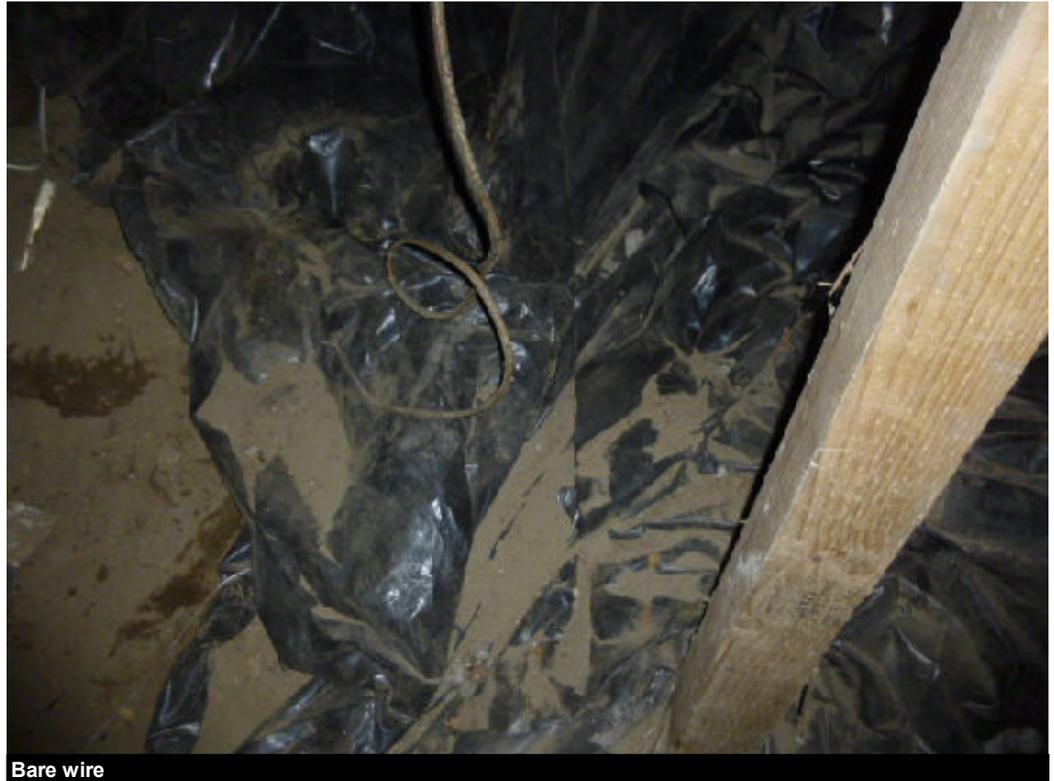
Bare wire

The following type of branch wiring was found throughout the structure: Copper wire, The following wire system is present: Romex, All visible wiring appears functional. Bare wires are noted in crawlspace under house. Wires need to be secured in junction box. Have a licensed electrician make further evaluation and corrections as needed.

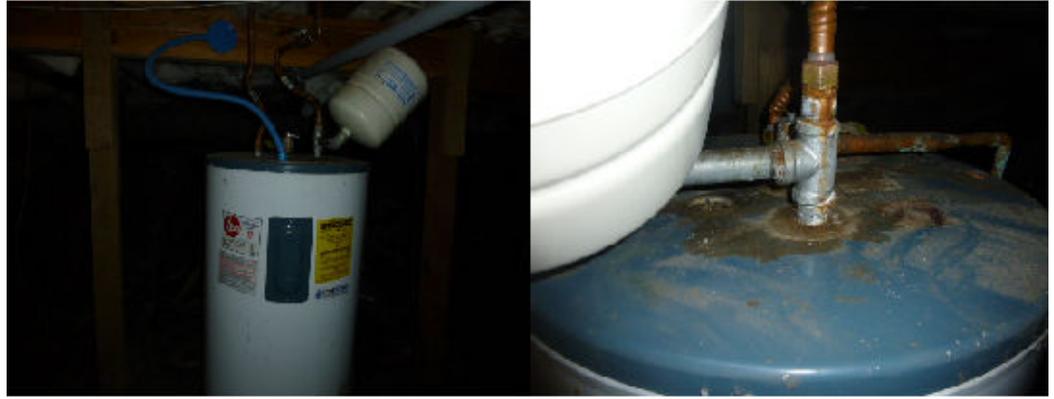
Water heaters typically last approximately 10-15 years. The water heater appears to be at or past its useful service life, however, unit appears to be functioning properly at time of inspection. Check water temperature upon moving in - 120 deg. or less is recommended. A water shut-off valve is installed. Pressure relief valve noted, not tested. Drain line is functional. Missing earthquake strapping was noted at water heater. Recommend adding metal strapping to secure tank to surrounding walls. Corrosion is noted at water connections.

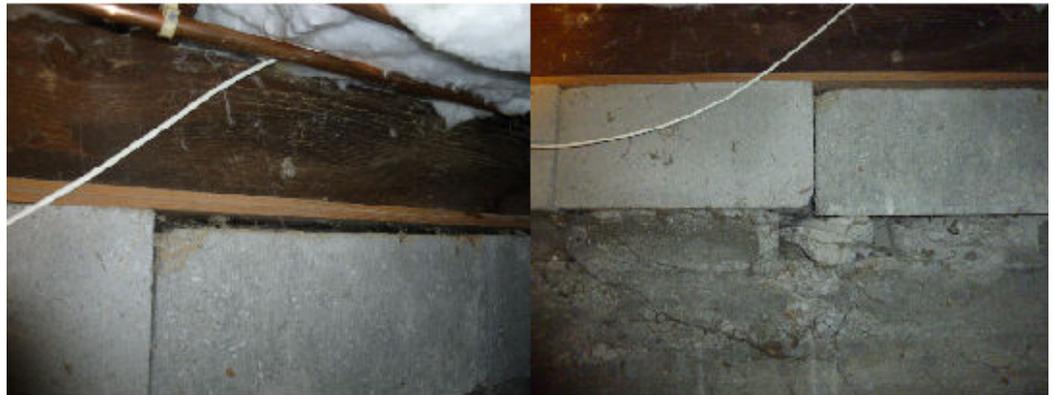
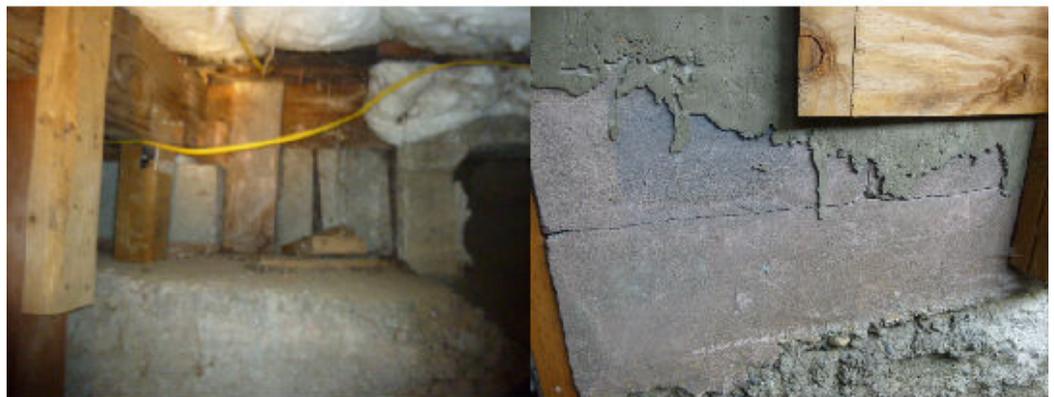
Foundation structural issues

The concrete stem walls are original to the home. A course of concrete blocks appear to have been added between the top of the stem wall and sub-floor structural members. These blocks only appear to have been set on top of the stem wall. Some blocks were used as fillers where significant gaps were present around the stem wall at the front foundation wall. No mortar, rebar, or ties/strapping were found to be securely attaching blocks to stem wall. Furthermore, a proper sill plate was not present on top of the blocks. Some blocks have moved/displaced with obvious settlement. It appears that the house structure may have been raised/lifted at one point to add the these

blocks above the stem wall. Old abandoned saddle impressions were noted within the original concrete foundation stem wall. At the exterior, a thin layer of concrete was found to be spread over the blocks and stem wall in areas, however, this is not a structural solution tying the stem wall to the blocks. Due to the significant alterations at the homes foundation, it is strongly recommended that a licensed structural engineer be consulted for further evaluation and repairs.

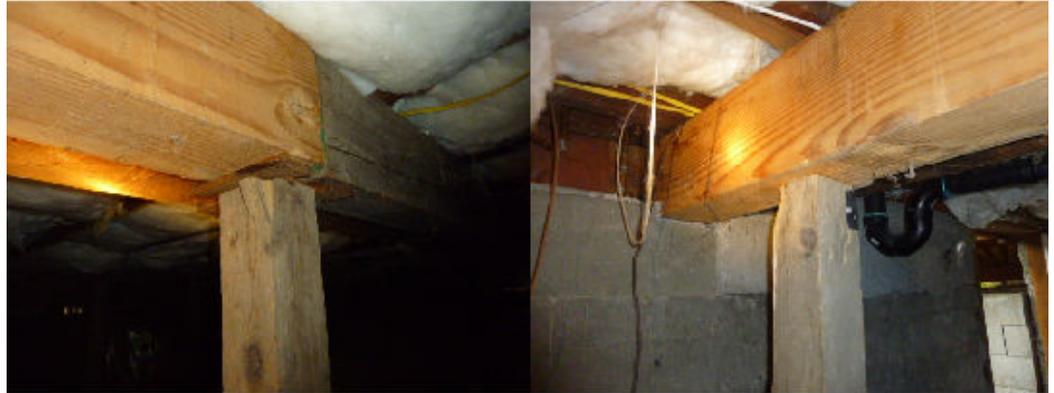
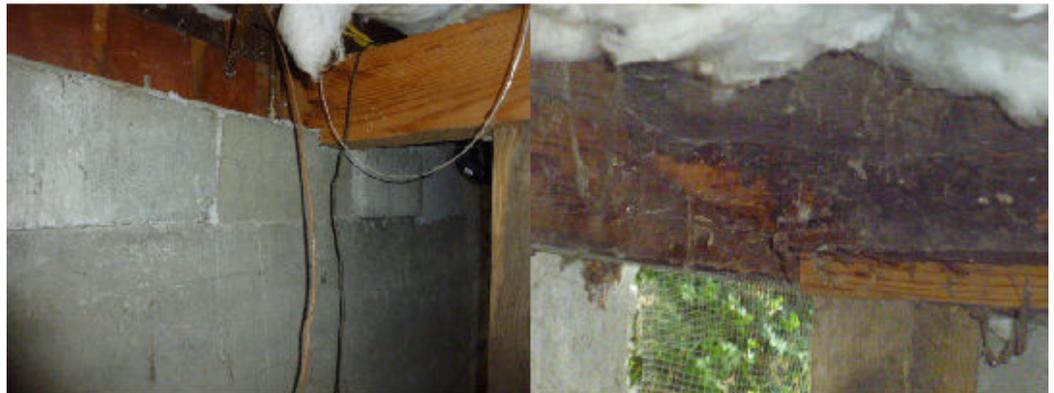
Wood beams; It appears that beams have been recently added to help support the structure. Beams were not properly tied to butting beams and support posts creating an unstable support structure. Obvious wood decay and WDO infestation was present at abandoned beam near front foundation wall. A new beam was found to be scabbed to the old damaged beam. This is not recommended. Additionally, poor support was present at ends of beams on stem wall/blocks. Further evaluation and repairs are needed by a licensed foundation contractor/structural engineer.

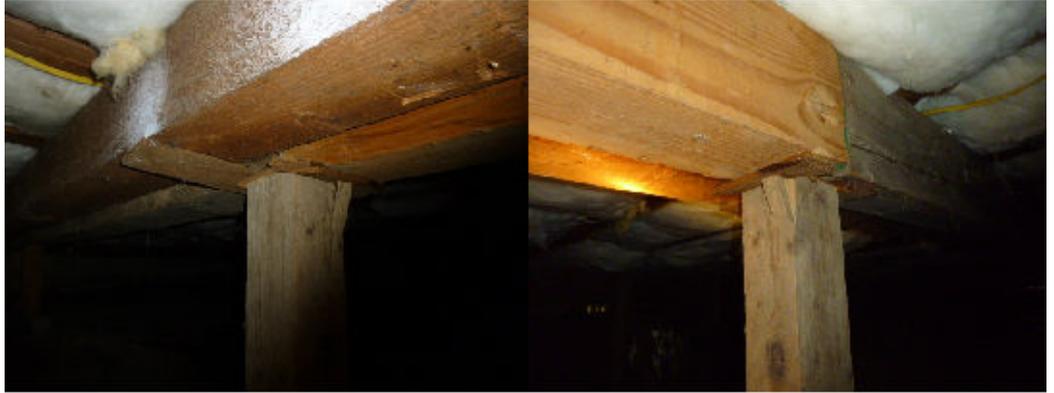
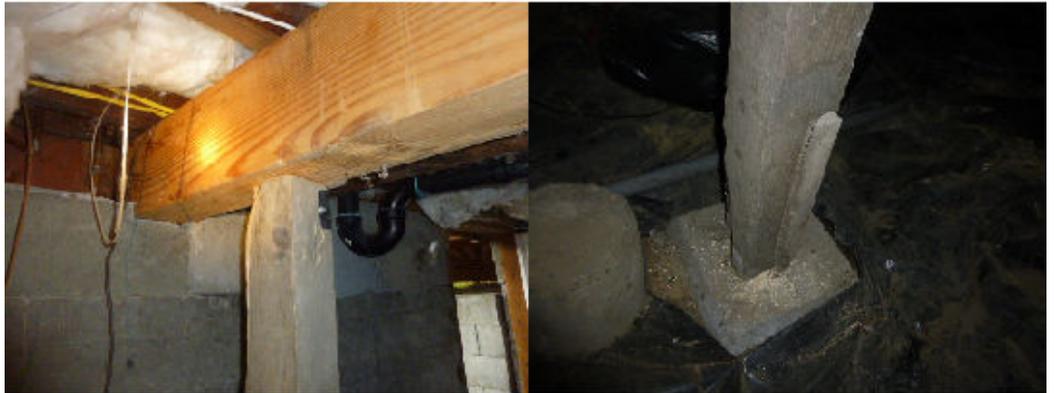
Wood support posts; Posts were found to be set improperly on undersized pier blocking. This can lead to settlement and movement of posts. Furthermore, wood support posts were not properly tied with positive strapping to the beams or pier blocks below. This can lead to dislodgement and structural compromise during earthquakes or settlement issues. Posts were also found to be undersized and not supporting the beams above properly. Further evaluation and repairs are strongly needed by a licensed foundation contractor/engineer prior to close of escrow .
